# Community Name Phase 2 – Roofing Progress Report

**Project:** Phase 2 Roof Replacement **Period:** July 20–26, 2026 **Prepared for:** HOA Board **Date:** July 26, 2026  
**Lead:** Mike R.

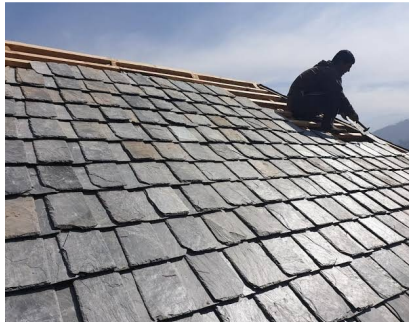
### 1. images (5).jpg

- # Roofing Observation Report
- Material\*\*: Slate or slate-like tiles, gray/charcoal color, installed in staggered pattern
- Coverage\*\*: Large roof section visible; appears to be mid-to-upper slope area
- Tile condition\*\*: Tiles appear intact with consistent color and positioning across visible surface
- Mortar/joints\*\*: Dark grout lines visible between tiles; no obvious sepa...

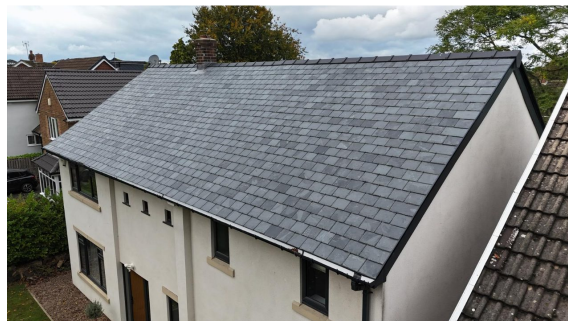
### 2. New-Slate-Roof-Installation-in-Walton-Wakefield.jpg

- # Roofing Observation Report
- Roof covering\*\*: New slate tile installation, appears to be uniform dark gray/charcoal color across main ro...
- Roof condition\*\*: Tiles appear properly seated with consistent alignment and spacing; no visible slippage o...
- Perimeter details\*\*: White painted fascia and soffit visible; black-painted gutters present along roof edge
- Flashing\*\*: Me...

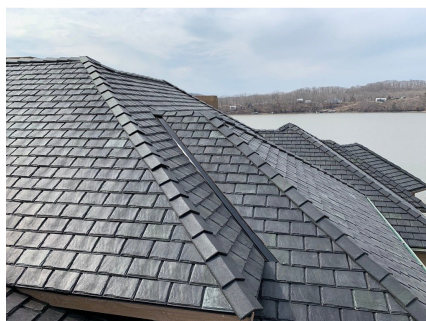
### 3. img\_2712.jpg-1024x768-8208e7f.jpg

- # Roofing Observation Report
- Material\*\*: Dark gray/charcoal architectural asphalt shingles; appears to be a multi-plane roof system
- Coverage\*\*: Multiple roof planes visible with valley and ridge intersections; adequate shingle overlap observed
- Condition\*\*: Shingles appear intact with no visible missing or lifted shingles in accessible areas
- Valley detail\*\*: Metal valley...

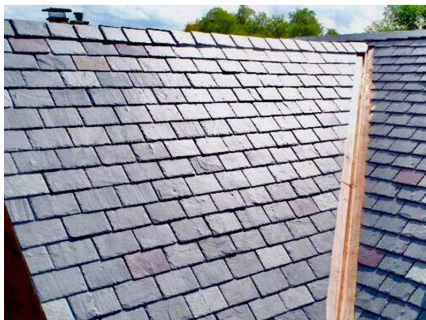
#### 4. exterior-remodel-design-project\_0038\_Richardson-Slate.jpg

- # Roofing Observation Summary
- Material\*\*: Natural slate tiles in grey/charcoal tones installed in staggered coursing pattern
- Visible condition\*\*: Slate appears intact with no obvious broken or missing tiles in view
- Surface weathering\*\*: Even patina across visible slates; consistent aging appearance
- Roof pitch\*\*: Moderate to steep slope visible on both roof planes

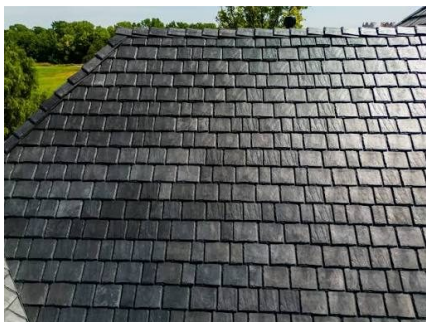
#### 5. images (4).jpg

- # Roof Observation
- Material\*\*: Asphalt or composite shingles, dark gray/charcoal color
- Coverage\*\*: Two roof planes visible with standard shingle overlap pattern
- Surface condition\*\*: Shingles appear intact with no visible missing, cracked, or curled sections
- Wear pattern\*\*: Slight color variation across planes — may indicate age difference or sun exposure variation

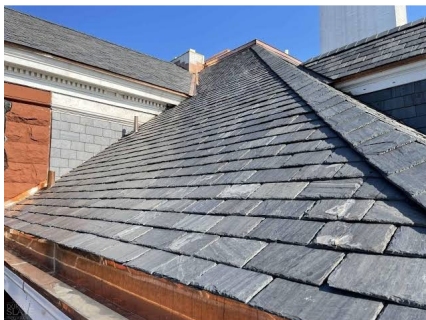
#### 6. images (3).jpg

- # Roof Observation Report
- Material\*\*: Dark slate or slate-like shingles in standard overlapping courses.

- Visible condition\*\*: Shingles appear intact with no obvious cracking, missing pieces, or major deterioratio...
- Surface finish\*\*: Slight weathering and color variation visible; consistent with age/exposure.
- Drainage\*\*: Roof slope adequate for water runoff; gutter/fas...
