# Roof Inspection Report – [Community Name] Buildings D, E, F

**Subject / Property:** [Community Name] – Buildings D, E, F **Inspection date:** July 28, 2026 **Prepared for:** [Community Name] Management **Date prepared:** July 28, 2026 **Roof type:** Asphalt 3-tab shingle **Access method:** Ladder and walkable sections; limited attic access via hatches

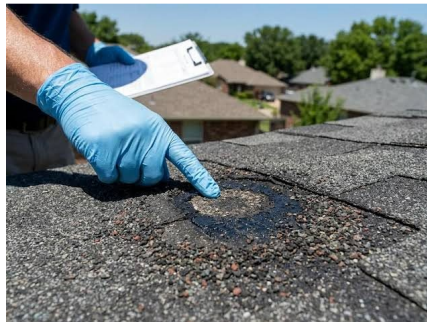
## 2. images (7).jpg

- # Roofing Inspection Observations
- Material:\*\* Asphalt shingle roof visible in background; inspector examining granulated surface in foreground
- Defect observed:\*\* Dark discoloration/staining on shingle surface with possible moisture penetration or algae growth
- Granule loss:\*\* Visible exposed aggregate and loose granules in inspection area
- Shingle condition:\*\* Surface shows wear and tear

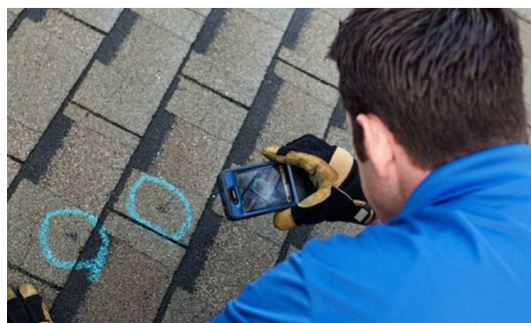
## 3. G\_Fedale\_Roof\_Inspesctions.jpg

- # Roof Inspection Observations
- Material:\*\* Asphalt composition shingles with dark-colored tabs and lighter field color
- Shingle condition:\*\* Shingles appear intact with no visible tears, splits, or missing pieces in view
- Granule loss:\*\* Light granule surface texture visible; no obvious bare spots or excessive wear
- Chalk markings:\*\* Blue chalk grid marked on roof surface for measurement and documentation
